LEE POND DAM

MA 00891

PHASE I INSPECTION REPORT  
NATIONAL DAM INSPECTION PROGRAM

JULY 1981

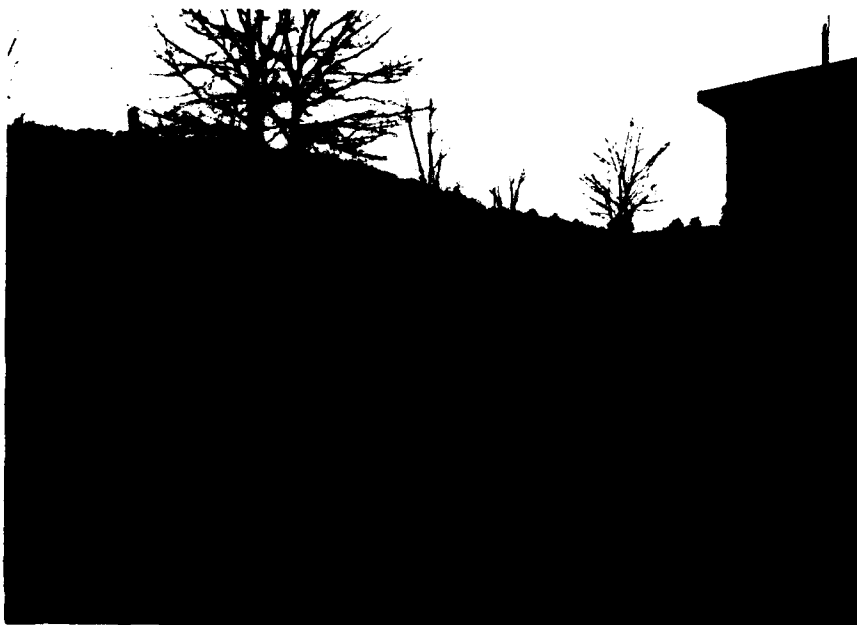
Photo # 3 Vertical wall at downstream face of dam

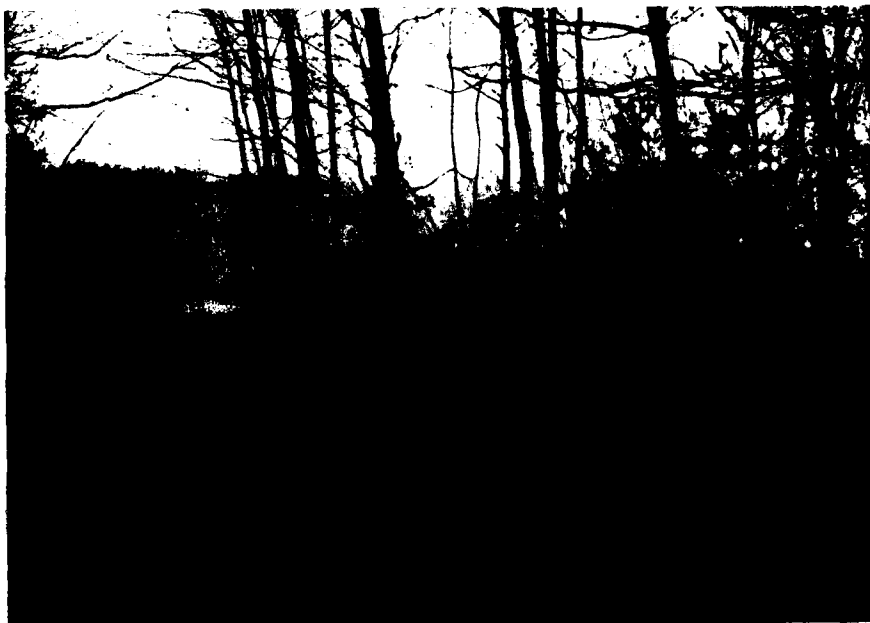
A stream at the right abutment forms a natural spillway for the dam (Photo #6). An outlet structure containing an inoperable sluice gate is located on the upstream side of the crest opposite the mill building. The gate appeared closed at the time of inspection. Minor erosion has occurred at the stone masonry entrance to this outlet. The wing walls for this outlet are of stone masonry and are in poor condition (Photo #7). A flow of about 1 cfs was noted at the downstream end of the flume for this outlet.

The natural stream spillway channel is partially blocked with logs, branches, leaves and other debris. The streambed and banks are formed by natural materials, including soils, boulders and bedrock (Photo # 6). The banks are generally oversteepened and rise no higher than approximately 1.5 ft. The flume for the outlet structure passes under the old mill structure which is partially collapsed, exits in back of the mill, disappears underground in an apparent stone conduit, and reappears as a natural stream channel about 125 ft. downstream of the mill. The observed portion of the conduit under the mill was constructed of stone.

Photo # 6 Natural stream at spillway, looking upstream  
(Approximately 10 ft. wide)
